# MICROSCOPIC EXAMINATION OF STEEL

HENRY FAY, Ph. D., D. Sc.

*Professor of Analytical Chemistry, Massachusetts Institute of Technology  
Consulting Metallurgist, Watertown Arsenal*

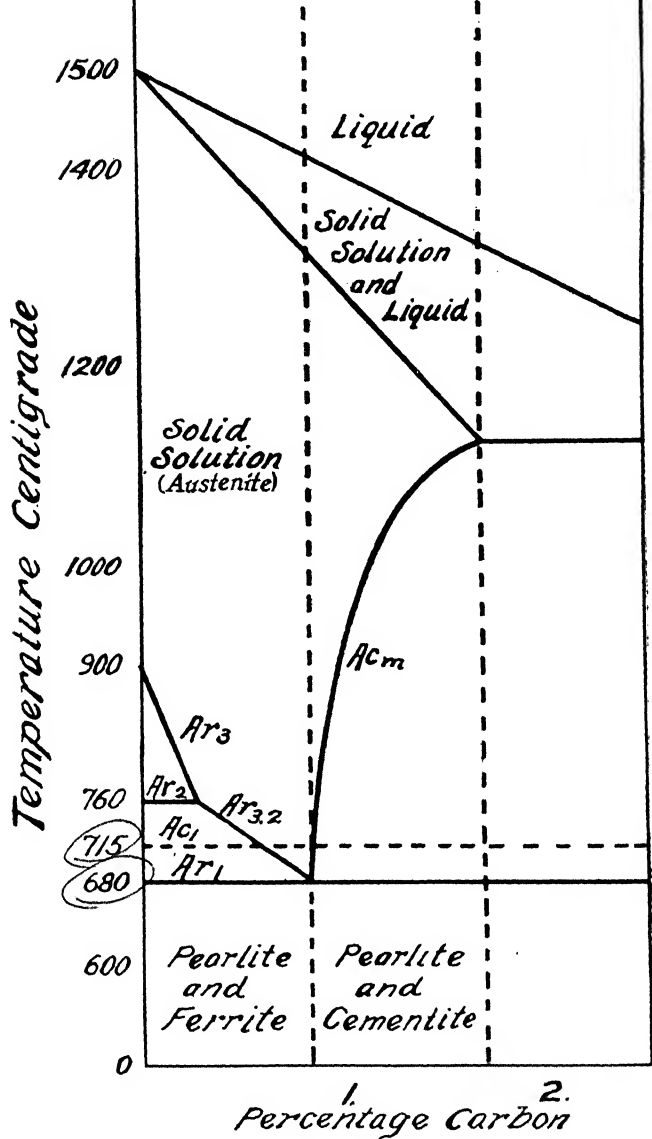
Fig. 1

Portion of iron-carbon diagram

constituents, iron and iron carbide. The  $Ac_1$  point is approximately  $30^\circ$  higher than the  $Ar_1$  point, and represents the beginning of the formation of solid solution. In steels containing 0.85 per cent carbon there is but one critical temperature at which the solid solution decomposes into its constituents, iron and iron carbide. This is known as an eutectoid steel, and its microscopic constituent is pearlite. Pearlite always etches dark, and under high magnifications is shown to consist of alternate laminations of iron and iron carbide. Steels containing less than 0.85 per cent carbon are hypoeutectoid, and contain the microscopic constituents ferrite and pearlite, the amount of the latter increasing with the per cent of carbon. Steels containing more than 0.85 per cent carbon are hypereutectoid, and contain the microscopic constituents cementite (iron carbide,  $Fe_3C$ ) and pearlite. These facts are illustrated in the diagram. (Fig. 1.)

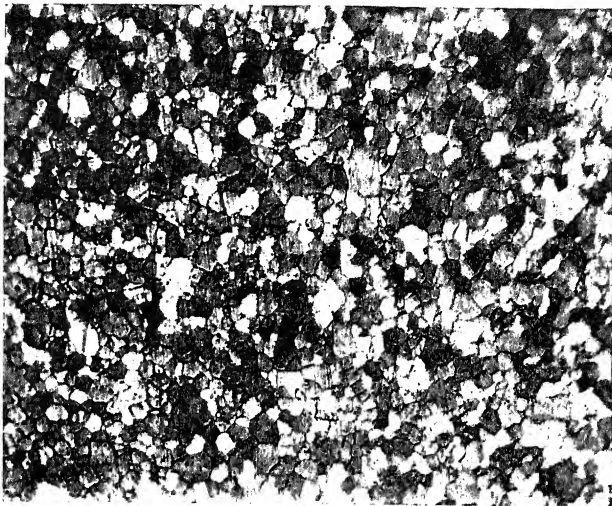
PHOTOGRAPH NO. 1. X75.

0.06% carbon. Approximately pure ferrite.

Photograph No. 1 shows the characteristics of a carbonless iron in which the whole field is made up of granules of ferrite. With the introduction of carbon there is a decrease in the amount of ferrite and the constituent pearlite begins to appear. This is shown in photograph No. 2 for a steel containing 0.18 per cent carbon. Inasmuch as steels containing 0.85 per cent carbon contain 100 per cent pearlite, and as pearlite is composed of ferrite and cementite, in this steel containing 0.18 per cent carbon there ought to be approximately 20 per cent of the field made up of pearlite. In a steel containing 0.5 per cent carbon there should be 58.8 per cent pearlite. Such a steel is shown in photograph No. 4. A eutectoid steel containing 0.83 per cent carbon and practically 100 per cent pearlite is shown in photograph No. 7. Under higher magnifications pearlite shows the laminated structure shown in photograph No. 8. In hypereutectoid steels the excess carbon beyond that necessary to form pearlite, separates as free cementite and the amount of free cementite can be calculated. Inasmuch as the whole field is made up of pearlite

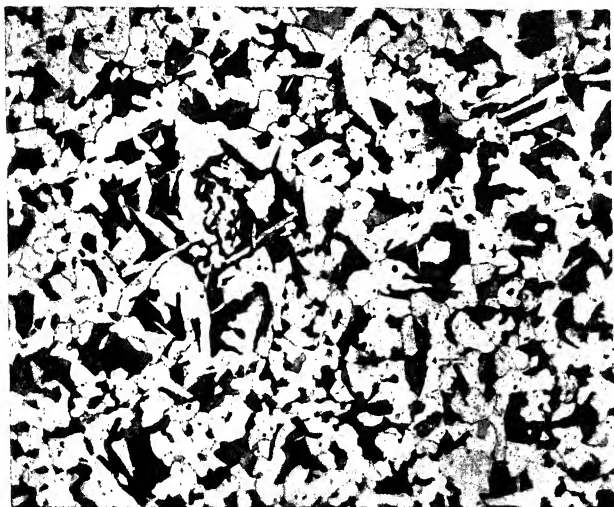
PHOTOGRAPH NO. 3. X75.

0.32% carbon. Ferrite (white) and pearlite (dark).

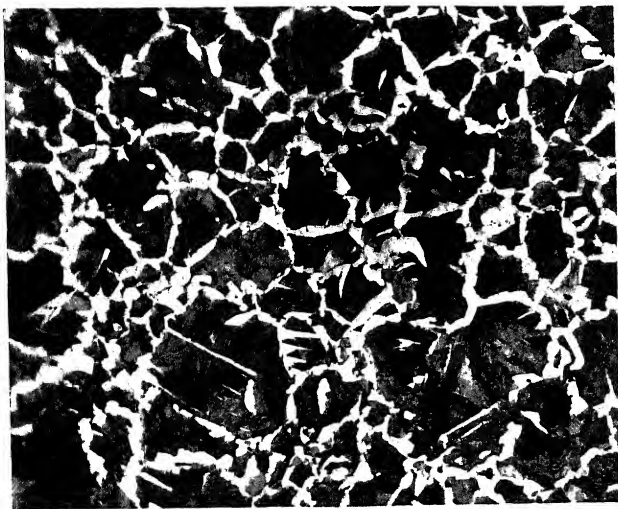
PHOTOGRAPH NO. 4. X75.

0.49% carbon. Ferrite (white) and pearlite (dark).

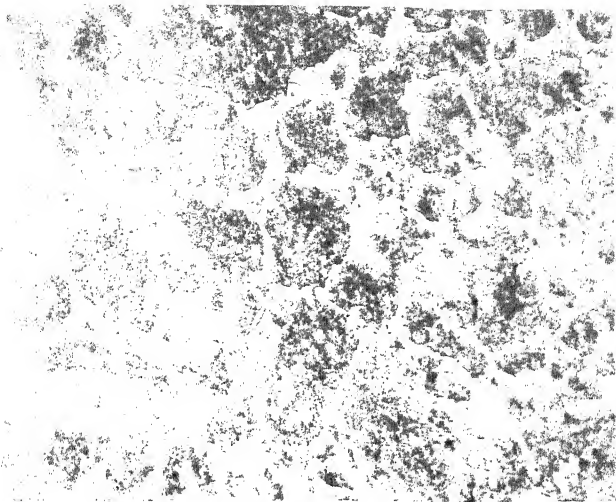
PHOTOGRAPH NO. 5. X75.  
0.57% carbon. Ferrite and pearlite.

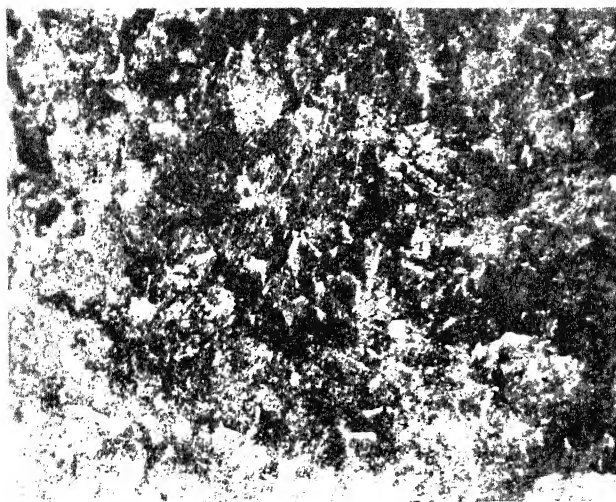
PHOTOGRAPH NO. 6. X75.  
0.71% carbon. Ferrite and pearlite.

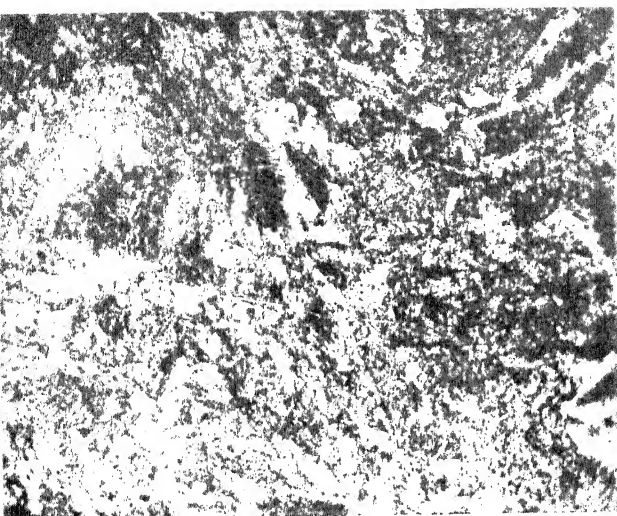
PHOTOGRAPH NO. 7. X75.

0.83 % carbon. Pearlite.

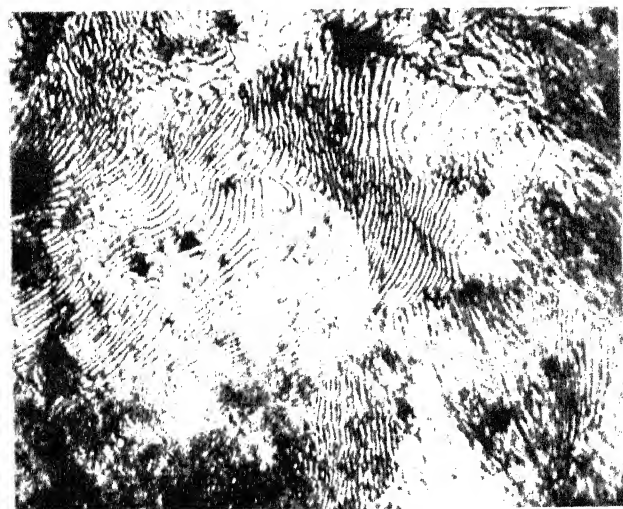
PHOTOGRAPH NO. 8. X485.

0.83 % carbon. Pearlite.

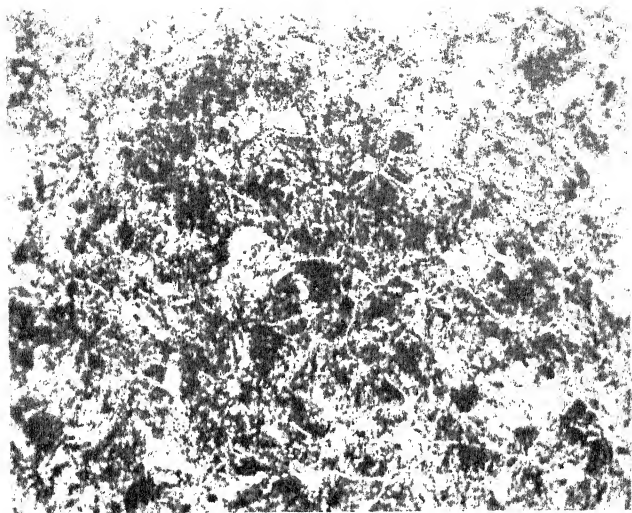
PHOTOGRAPH NO. 9. X75.  
1.22 % carbon. (Pearlite and cementite (white).

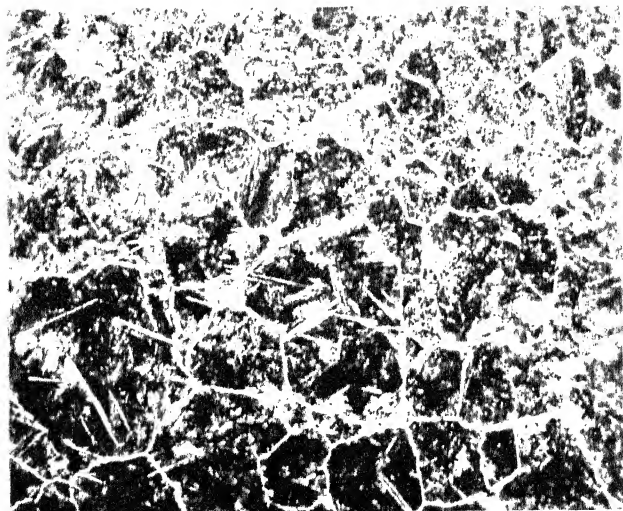
PHOTOGRAPH NO. 10. X75.  
1.46 % carbon. (Pearlite and cementite (white).

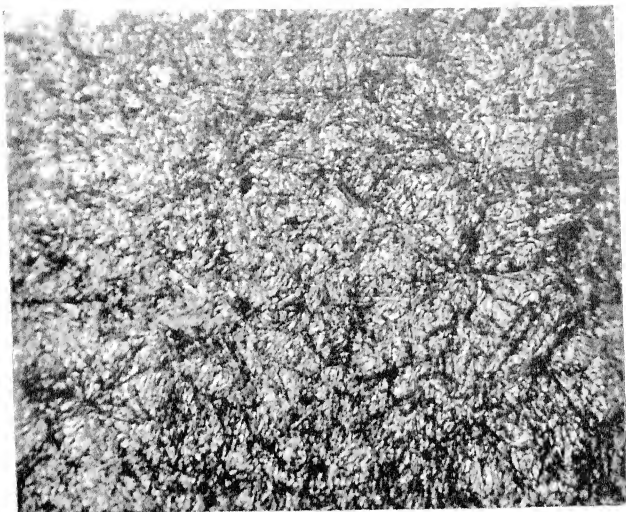
PHOTOGRAPH NO. II. X75.

Martensite.

Photograph No. 11 shows the characteristic appearance. Commercially martensitic steels are unimportant on account of their extreme brittleness and they are found only rarely.

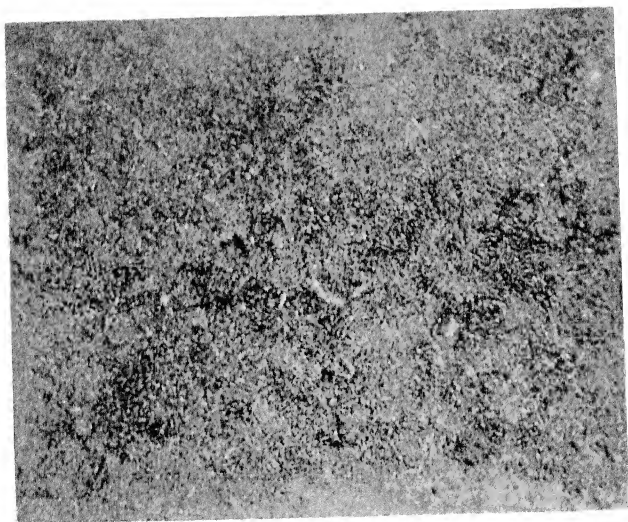
PHOTOGRAPH NO. 12. X75.

Troostite.

If heated to temperatures below  $A_{c1}$ , the effect produced will vary with the temperature. The lower the temperature of reheating the smaller is the tendency toward stable equilibrium; the higher the temperature the more stable is the product produced. Practically any degree of hardness may be produced, varying from glass-hard to extreme softness, by properly regulating the temperature of the heating. There are then two extremes, the martensitic steels formed by quenching from above  $A_{c1}$  and the pearlitic steels formed by cooling slowly from  $A_{r1}$  or above. Intermediate between these extremes are steels in which more or less of the unstable solid solution has been partly converted to more stable forms. Such forms are represented microscopically by troostite and sorbite. Troostite, formed by tempering at relatively low temperatures, represents the first stage in the breaking down of the unstable equilibrium and is characterized by the amorphous or slightly granular structure. Etching with alcoholic nitric acid the surface usually blackens immediately from separated carbon. Photograph No. 12 shows troostite.

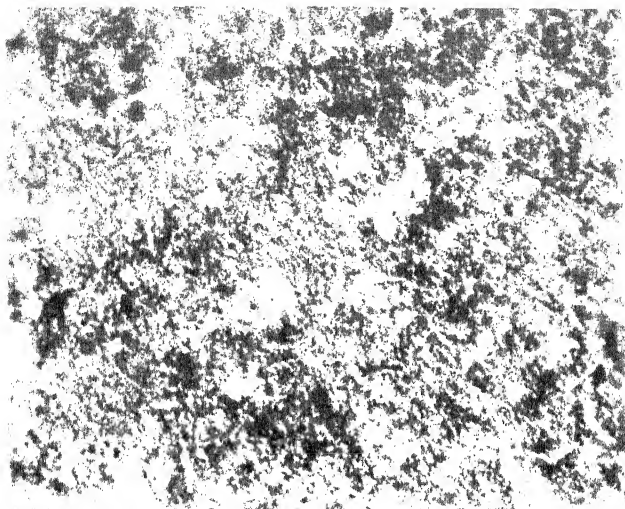
PHOTOGRAPH NO. 13. X75.

Sorbite.

Sorbite steels are those which have been quenched and heated to a higher temperature and thus represent a more stable state of equilibrium. They are characterized by having a peculiar grayish color, and the structure is better defined than troostite. The particles of iron carbide have not assumed definite lamellations with ferrite as in pearlite, but are very much more distinct than in troostite. Photograph No. 13 shows sorbite.

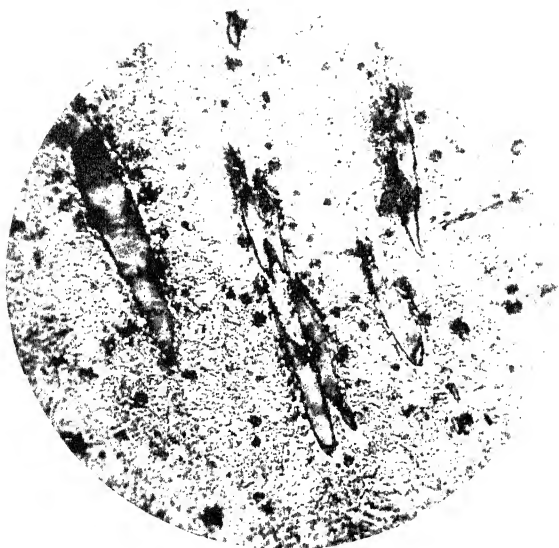
PHOTOGRAPH NO. 16. X50.

Sulphide of manganese in gun steel.

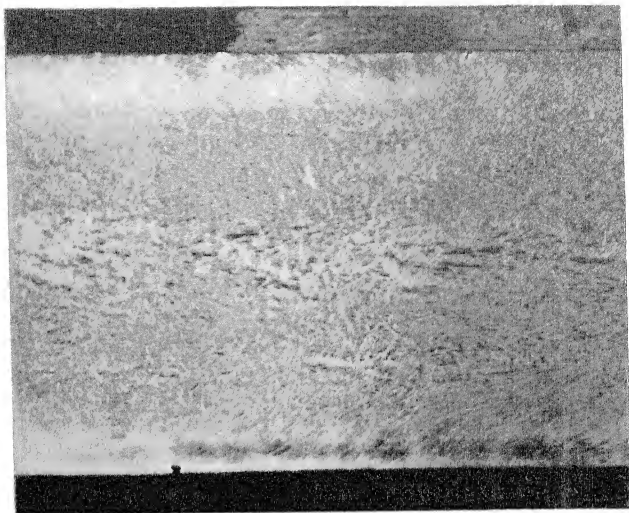
PHOTOGRAPH NO. 19. ONE-THIRD SIZE.  
Ingot structure in steel.

The presence of ingot structure such as shown in photograph No. 19 indicates that the heat treatment and forging have not been sufficient to wipe out the crystallization which occurred on the solidification of the metal. It is not definitely known that the presence of ingot structure is harmful, and it is frequently accompanied by excellent microstructure, but it serves as an indication of the heat treatment to which the metal has been subjected after solidification. It is believed that such a structure would not be found in the best steel, and it is further believed that metal showing ingot structure would be more liable to rupture from shock than metal in which the ingot structure had been wiped out by heat treatment and forging.

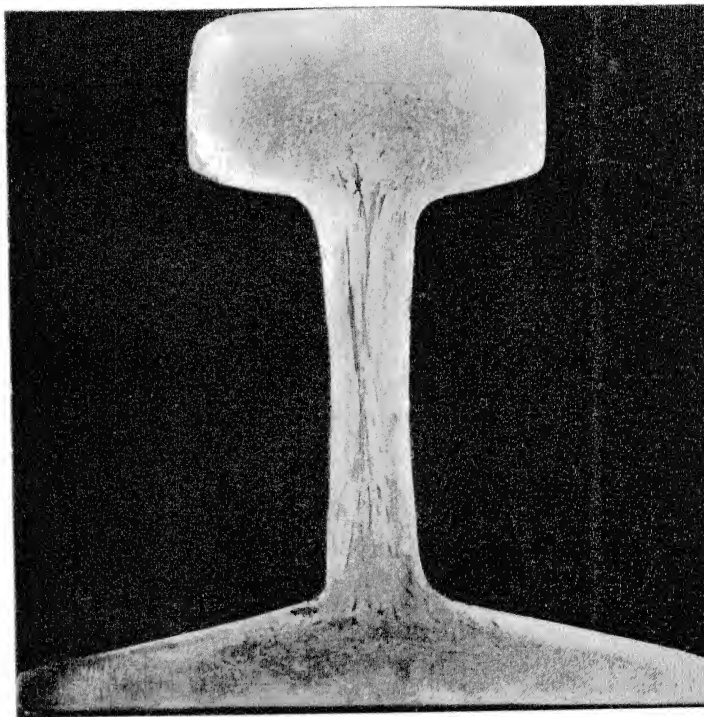
PHOTOGRAPH NO. 20.  
Cross section of steel rail showing segregation in center of head, web, and base.

Segregation of carbon or phosphorus may be brought out most successfully by etching a complete cross section of the metal under investigation, such as shown in photograph No. 20 of a rail section in which segregation of carbon is shown, or in photograph No. 21 of a cross section of a piece of cold-rolled shafting

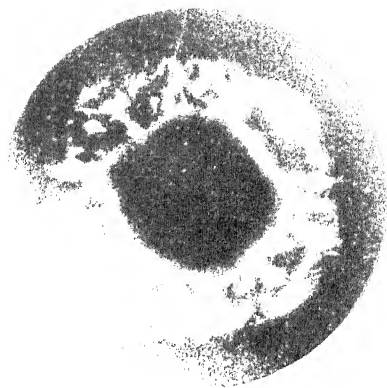
PHOTOGRAPH NO. 21.

Segregation of phosphorus in cold-rolled shattering.  
Etched with iodine. (White areas.)

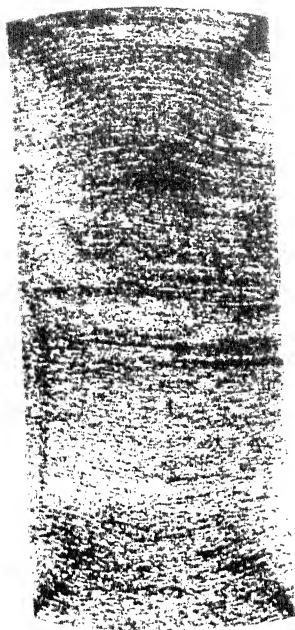
PHOTOGRAPH NO. 23.

Area of strained metal brought out by etching with copper ammonium chloride.

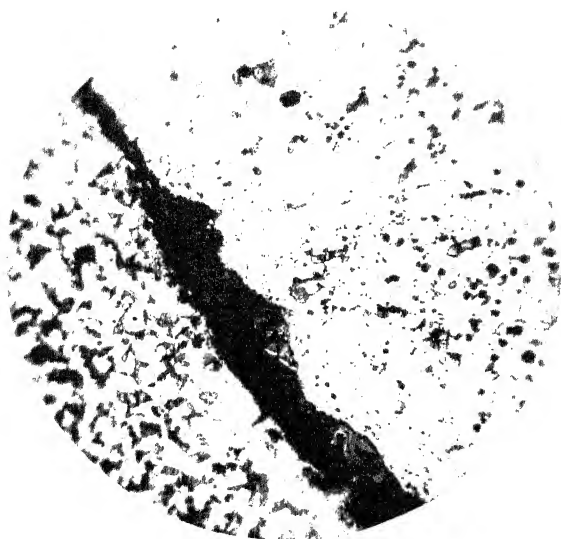
PHOTOGRAPH NO. 24. X50.

Crack, slag, and decarbonized area found on the base of a steel rail.

The inclusion of oxide is frequently accompanied by partial decarbonization, and is most frequently found on or near the surface. An example of this is shown in photograph No. 24, in which it is seen that a crack has penetrated through the slag, probably mill scale, and in the crack are the remnants of the slag. On the left of the crack is the normal structure and on the right is a decarbonized area containing slag. Such an area would probably be large enough to show to the naked eye and would be considered unsafe. Other examples of oxide inclosures are cited on pages 14 and 15, in the discussion of the failure of 10-inch gun and 14-inch gun lever.

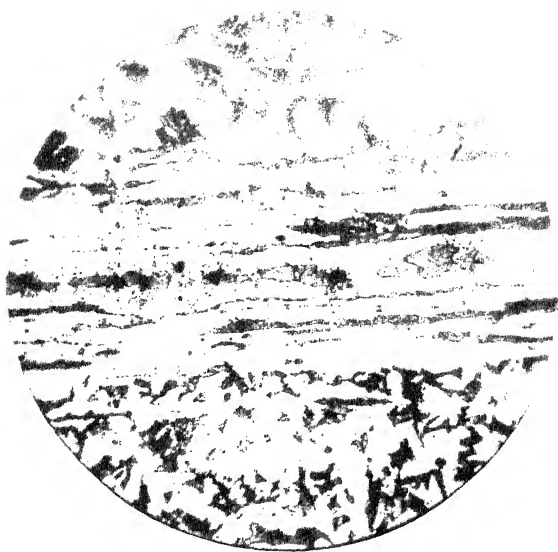
PHOTOGRAPH NO. 27. X50.

Microstructure of light-colored streak in No. 26.

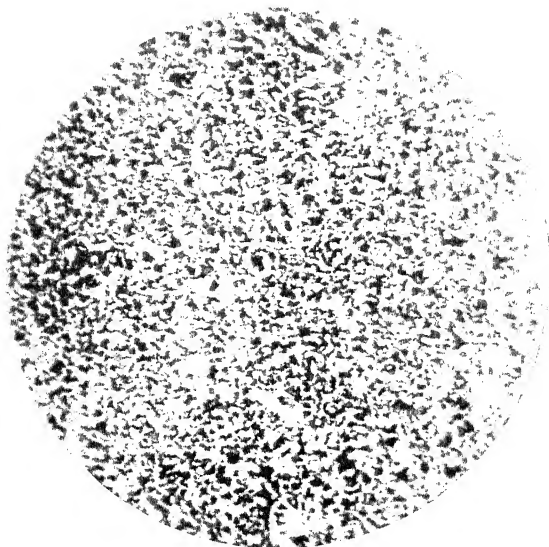
PHOTOGRAPH NO. 29. X75.

Microstructure of cast steel ingot forged to 1450° F. (788° C.)

Elastic Limit	50,500
Tensile Strength	83,600
Elongation	27.5

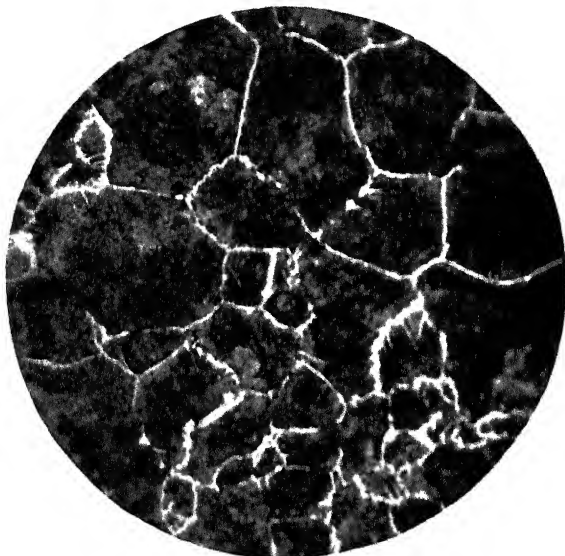
PHOTOGRAPH NO. 30. X75.  
Coarse microstructure in gun steel.

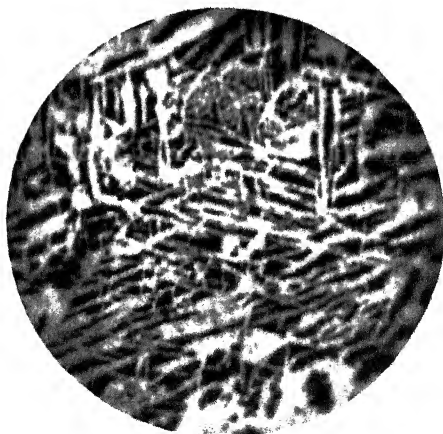
PHOTOGRAPH NO. 31 X50.  
Crystalline structure in rail steel.

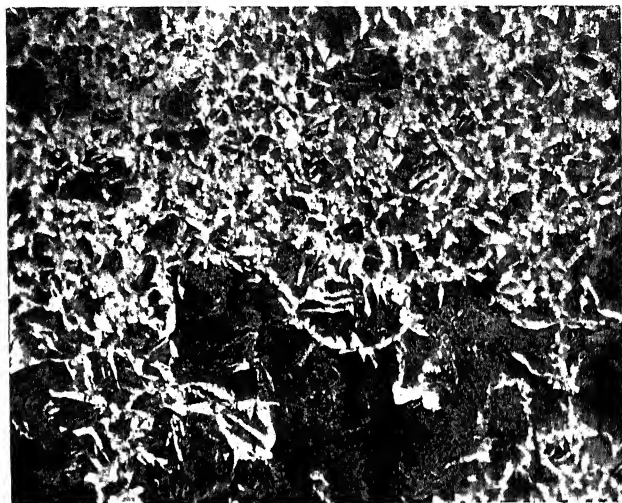
PHOTOGRAPH NO. 32. X75.

Microstructure showing Incomplete heat treatment.

Failure to obtain uniformity of structure is shown in photograph No. 32. Discussion of photographs Nos. 49, 51, and 53 will be found under the discussion of some of the special cases, viz., the failure of 14-inch gun lever arm. Dangerous overheating is shown in photograph No. 33. In this case the material is burnt, as is shown by the oxide between the granules of pearlite.

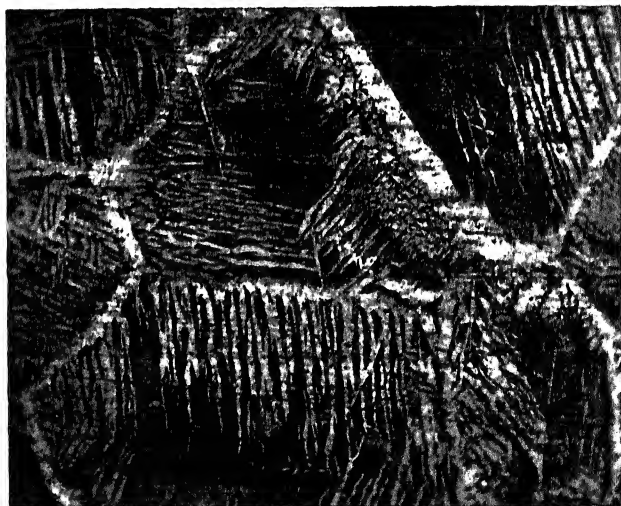
PHOTOGRAPH NO. 33. X75.

Microstructure of overheated steel.

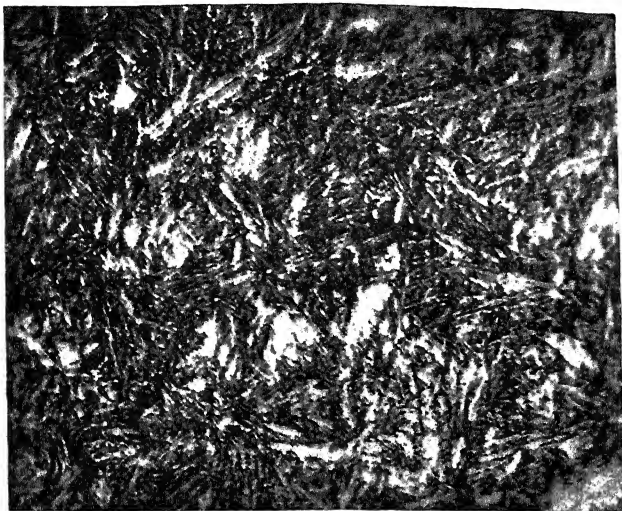
PHOTOGRAPH NO. 34. X500.

Microstructure of forging which had been originally martensitic, and in tempering this structure has not been completely eliminated.

observed that the original martensitic structure is completely removed by the tempering process. This point is illustrated by photograph No. 34 in which there are distinct remains of the original martensitic structure. Such a steel properly heat treated ought to show a structure similar to photographs Nos. 12 or 13.

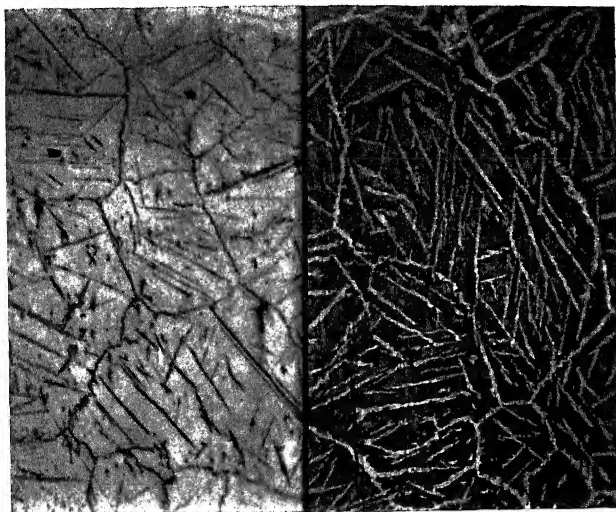
PHOTOGRAPH NO. 35. X65.

Microstructure in center of broken recoil spring showing excess cementite, indicating high carbon. Left, white lines are cementite etched with nitric acid solution; right, dark lines are cementite etched with sodium picrate solution.

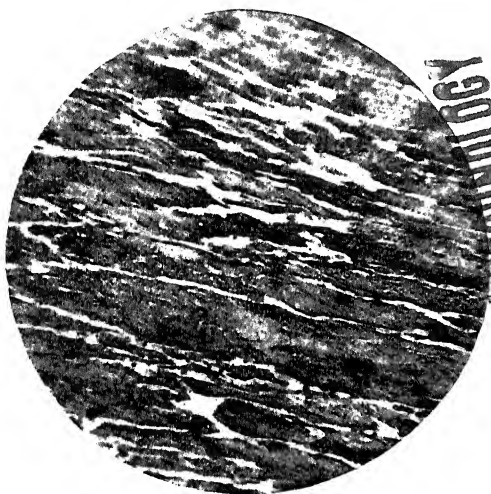
PHOTOGRAPH NO. 36. X50.

Microstructure of steel subjected to cold work, and  
showing distortion of grain.

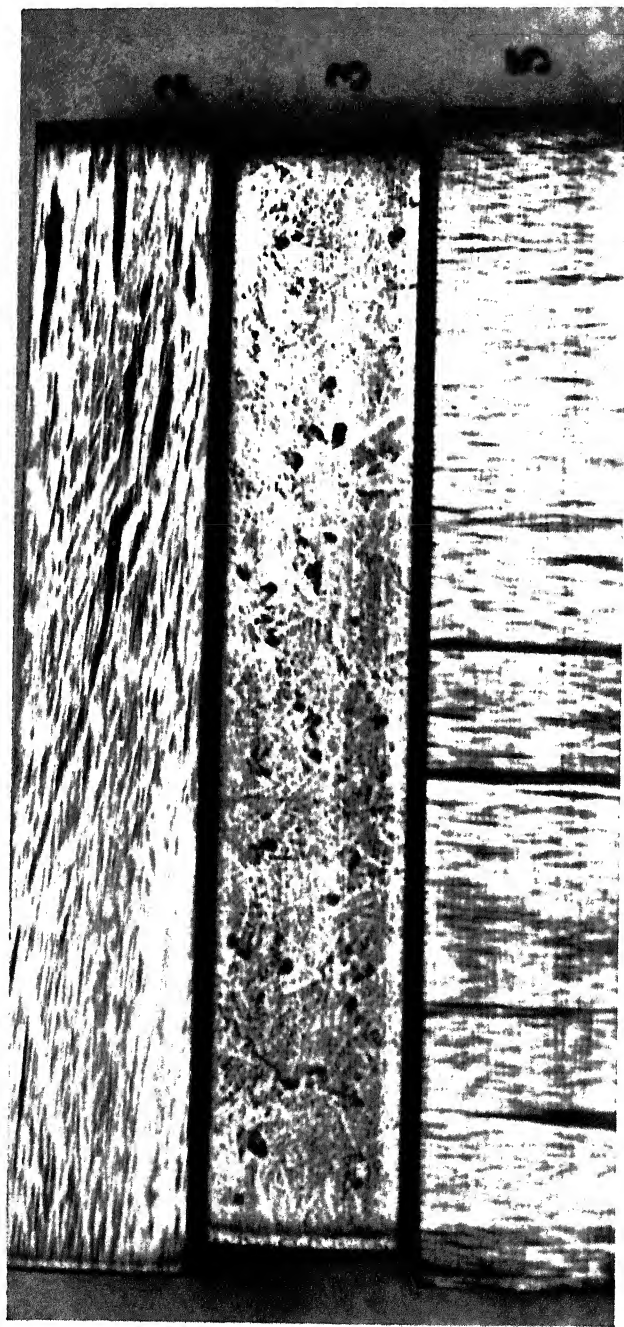
PHOTOGRAPH NO. 38.

Macrostructure of test bars of Olinchite, showing surfaces cut longitudinal 5 radial 3 and tangential 2 to axis.

Photographs Nos. 38 and 39 show the macrostructure of the steel when etched with iodine, the specimens shown in photograph No. 38 being taken longitudinally, radially, and tangentially. The segregation of phosphorus is indicated by dark lines in pieces Nos. 2 and 5 of photograph No. 38 and in pieces 1 and 3 of photograph No. 39 and by the dark spots in piece 3. Photograph No. 39 shows the metal cut from the surface of the fracture and treated in the same manner, as shown in piece marked 5 in photograph No. 38, and in other pieces not shown. The dark streaks were found to be elongated parallel to the direction of forging, and it is reasonable to assume that the elongation will always be parallel to the surface of the metal forged. By inspection of the two larger pieces of metal from the region of the crack (photograph No. 39) it will be noted that there is considerable distortion of the phosphide area

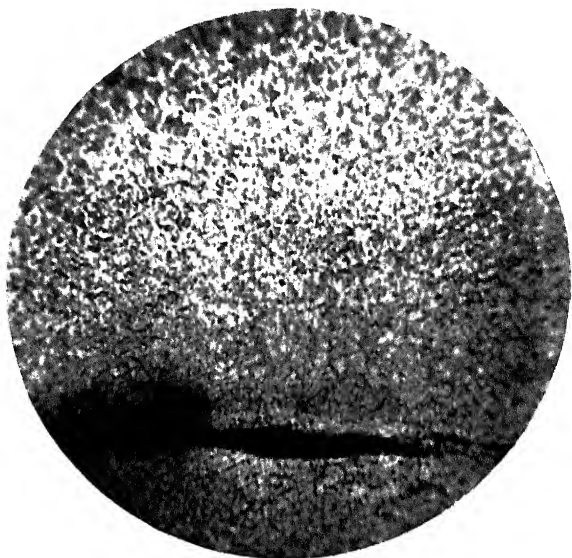
PHOTOGRAPH NO. 40. X50.

Crack and slag, with decarbonized area in 10-inch rifle.

Examination of sections in the vicinity of the crack showed many fine cracks, slag inclusions, and carbonless areas. The cracks led to slag, and where the slag was found there were also found decarbonized areas. Photograph No. 40 shows a crack ending in slag and surrounded by decarbonized iron. The course of the slag was quite irregular, as shown in photographs Nos. 41 and 42.

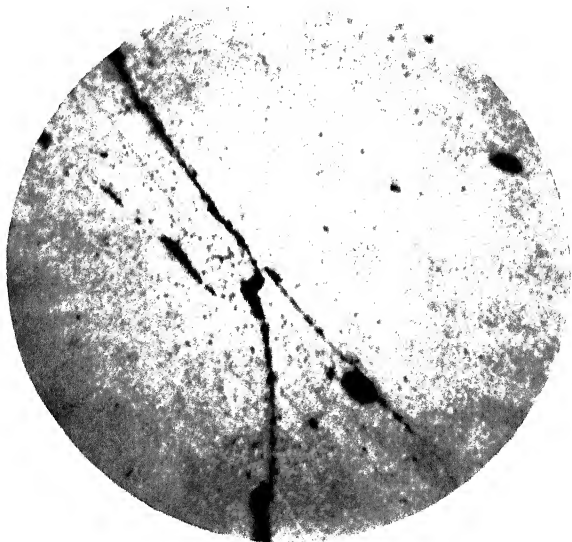
PHOTOGRAPH NO. 41. X50.

Slag in 10-inch rifle, unetched.

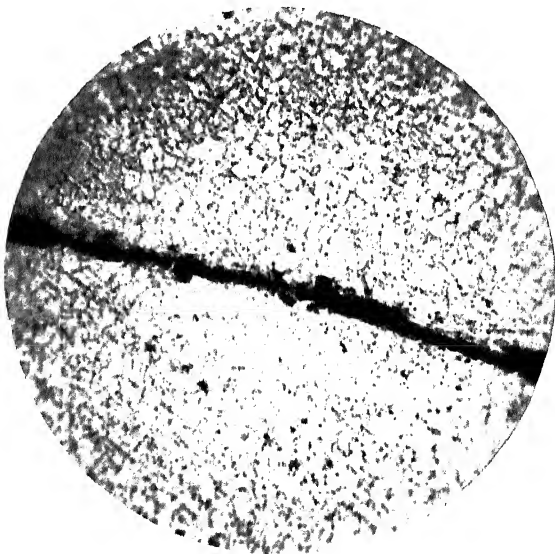
PHOTOGRAPH NO. 43. X50.  
Slag and decarbonized area in 10-inch rifle.

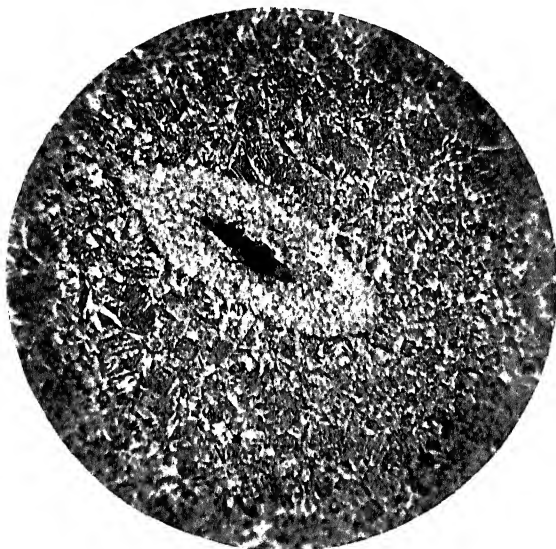
PHOTOGRAPH NO. 44. X50.

Island of slag in decarbonized area in 10-inch rifle.

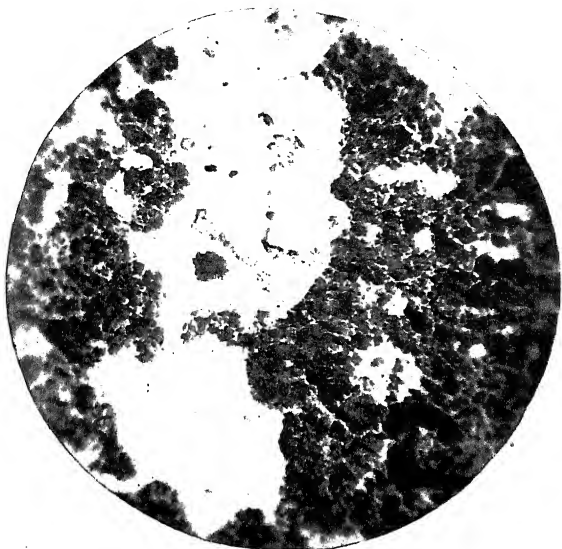
PHOTOGRAPH NO. 46. X50.

Fourteen-inch gun lever. Segregated ferrite (white) with slag inclosures.

This lever was made of cast steel and was broken during the test of the carriage. A microscopic examination revealed the structures shown in photographs Nos. 46 to 51, inclusive.

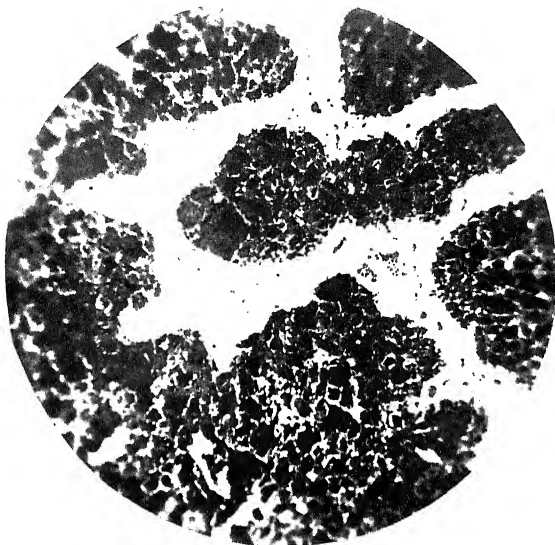
PHOTOGRAPH NO. 48. X50.

Fourteen-inch gun lever. Segregated ferrite (white) with slag inclusions.

In the fractured ends of the test pieces the metal shows decidedly bright spots, and these are due, it is believed, to the presence of the segregated ferrite. Further, it has been noticed that along the stem of the test pieces incipient cracks are developed, as shown in photograph No. 45. It is highly probable that these incipient fractures are developed in such areas as shown in photograph No. 47, which shows a large ferrite field at the edge of the specimen. It is possible that if the forces are transmitted equally throughout the test piece that such a portion would yield more readily where the carbon was lowest. The strength of such a spot would be approximately that of pure iron, or about 40,000 pounds per square inch, while the darker areas which contain more carbon would show considerably higher values. The presence of much slag in the ferrite areas would also increase the brittleness at this point, and would account for the low ductility in some specimens. Further examples of this form of segregation are shown in photographs Nos. 48 and 49.

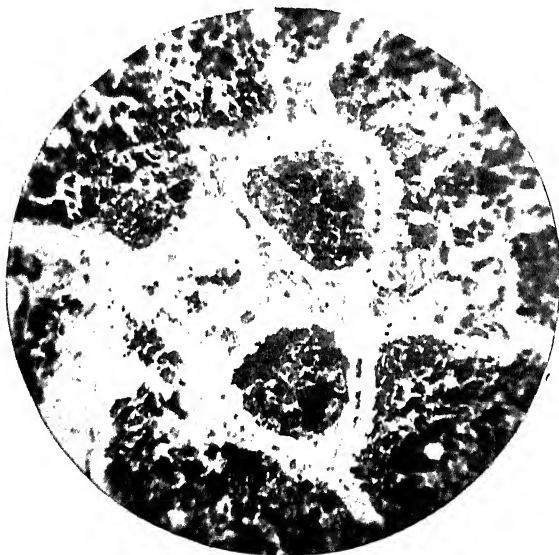
PHOTOGRAPH NO. 49. X50.

Fourteen-inch gun lever. Segregated ferrite with slag inclusions.

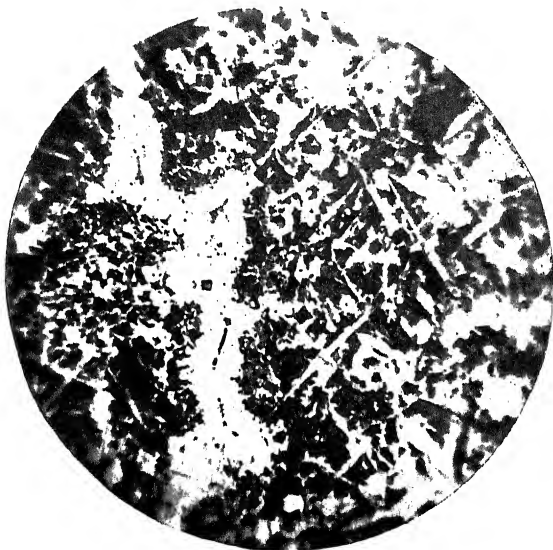
PHOTOGRAPH NO. 50. X50.

Fourteen-inch gun lever. Segregated ferrite and crystalline structure.

The metal has not been annealed in such a way as to remove the original crystallization which took place at the time of solidification. The crystalline structure is shown in photographs Nos. 50 and 51. Proper annealing should have completely wiped out all appearance of this kind. Evidence of this crystalline nature was found in all specimens examined, and it is highly

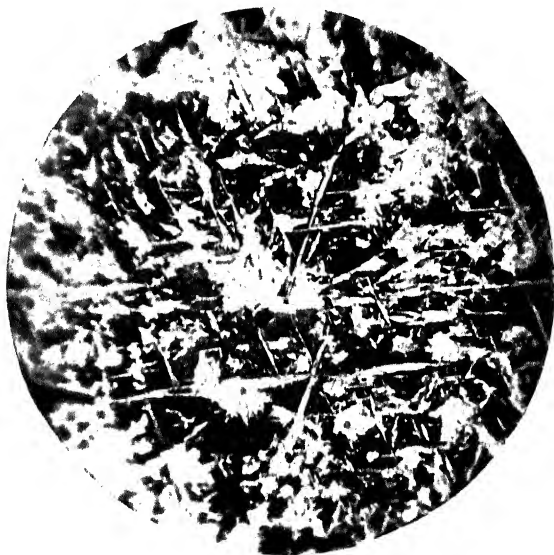
PHOTOGRAPH NO. 51. X50.

Fourteen-inch gun lever. Crystalline structure.

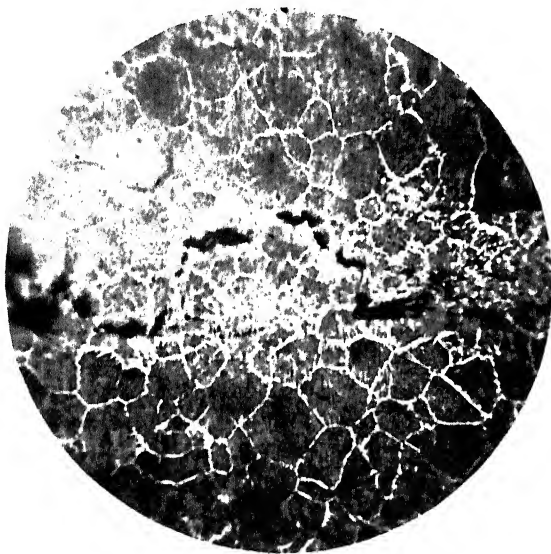
PHOTOGRAPH NO. 53. X50.

Twelve-inch gun. Microstructure showing slag and fissures.

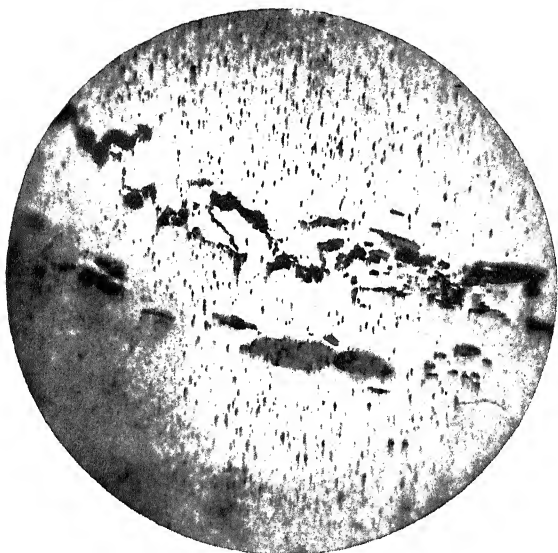
PHOTOGRAPH NO. 54. X50.

Twelve-inch gun. Slag in unetched specimen.

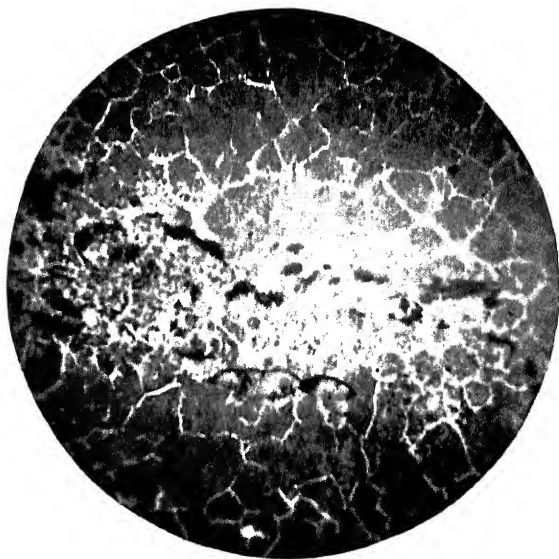
PHOTOGRAPH NO. 55. X50.

Twelve-inch gun. Same area as No. 54, etched with alcoholic nitric acid.
